Clean Oil - Longer Lifetime of the Gearbox

by Thomas Møller Andersen, C.C.JENSEN A/S

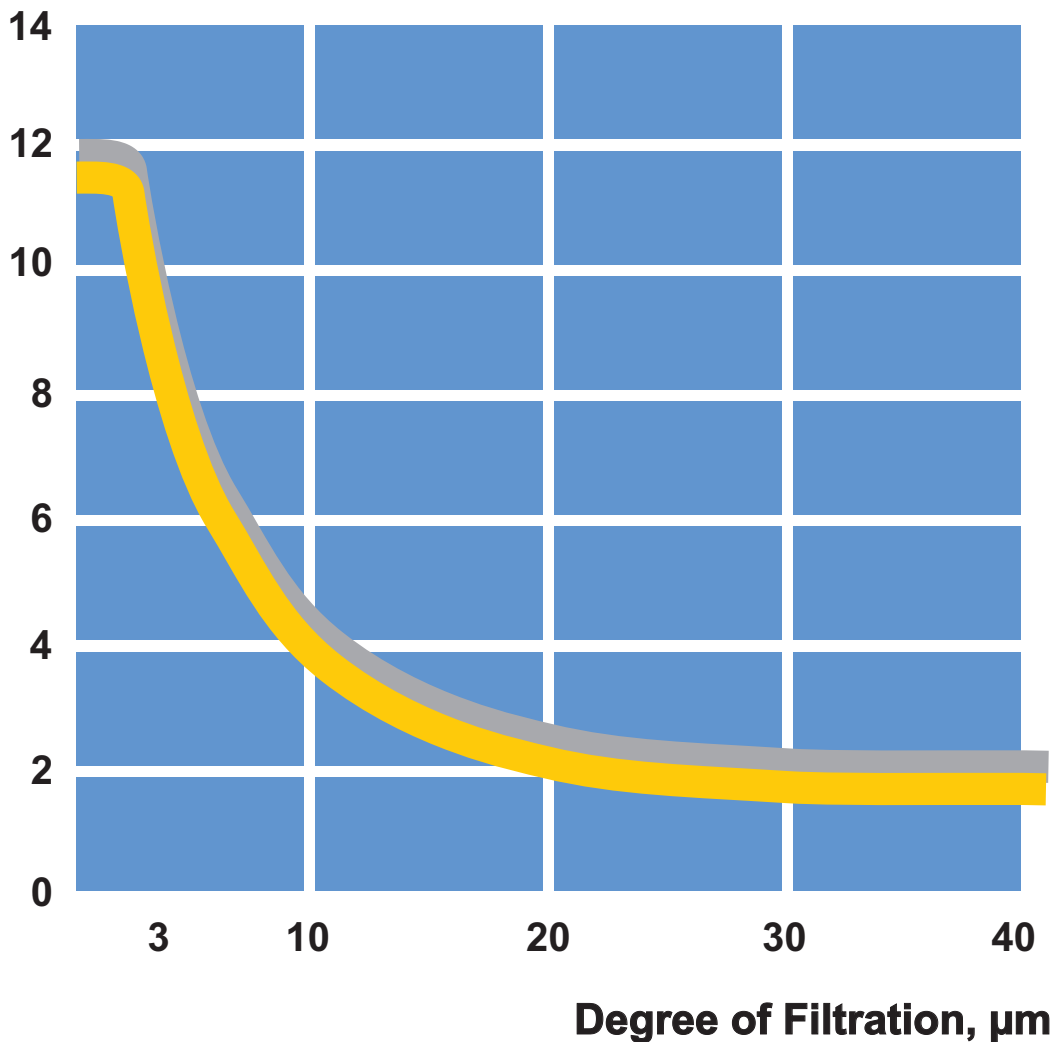
Testing period, 10^6 revs

The MacPherson Graph is based on an accelerated test of 10 roller bearings
The lubricating oil was contaminated with dirt from gearboxes

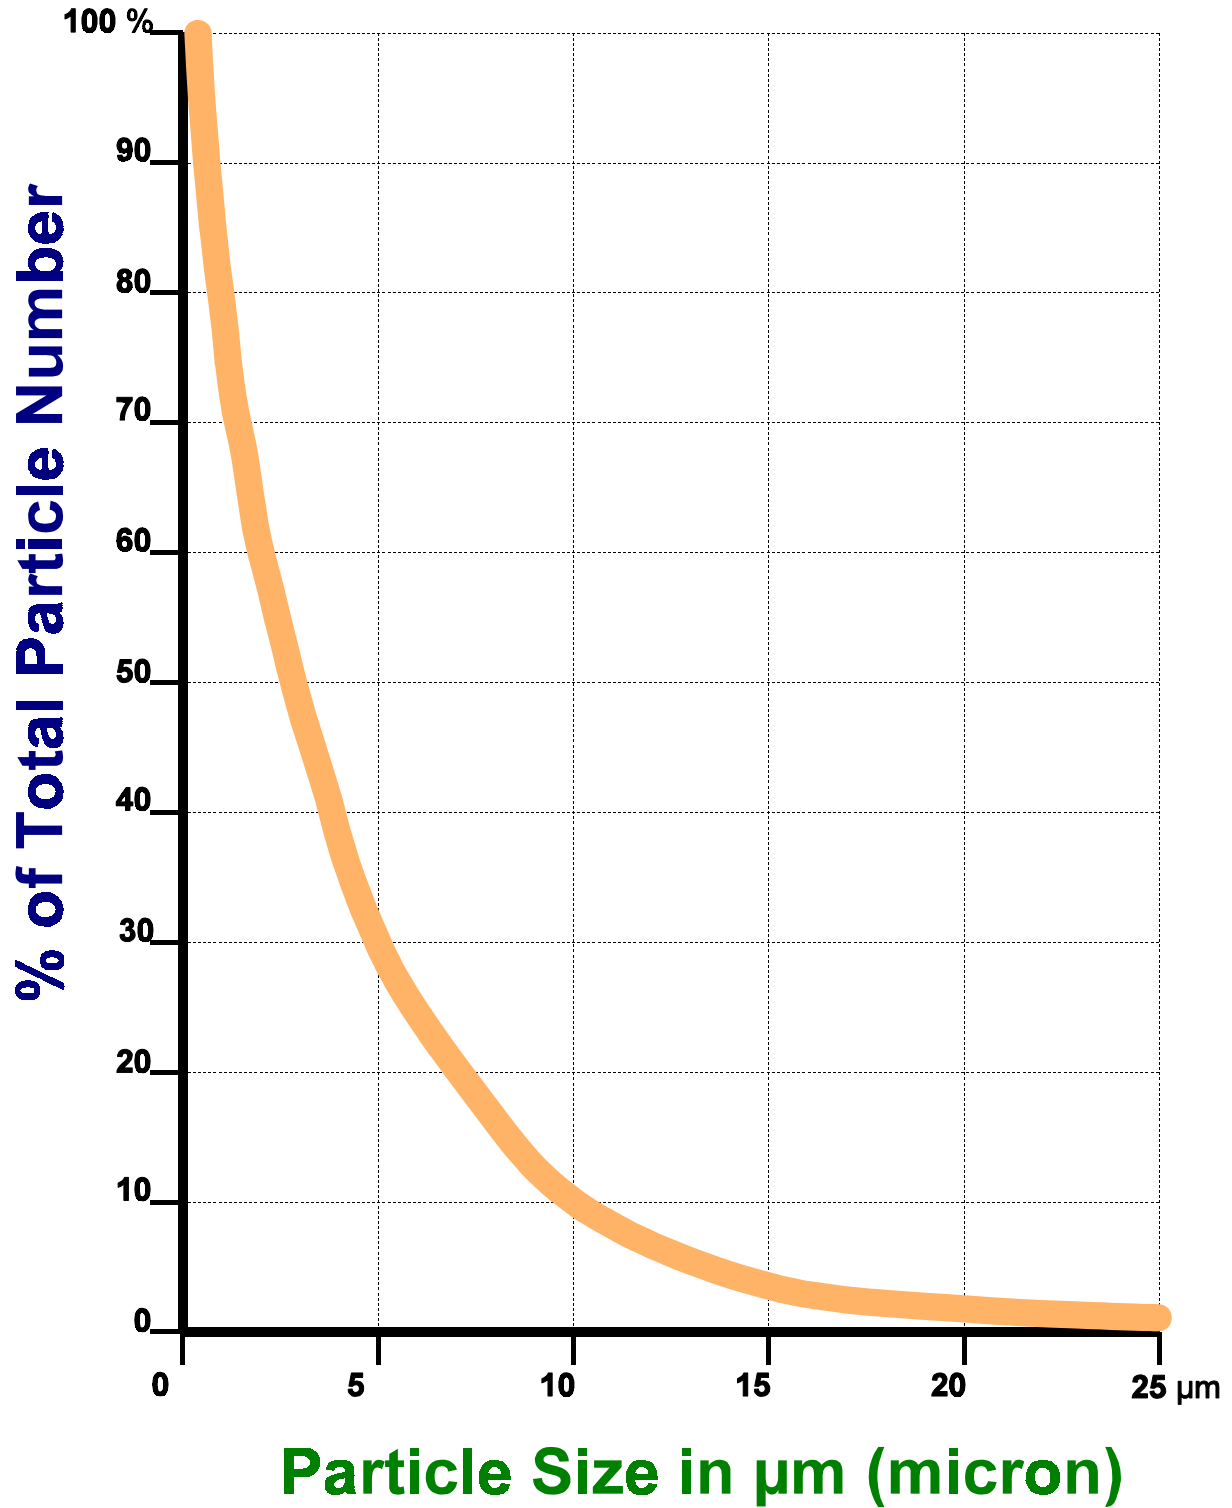
Particle Size Distribution

Observed average in medium charged system oils

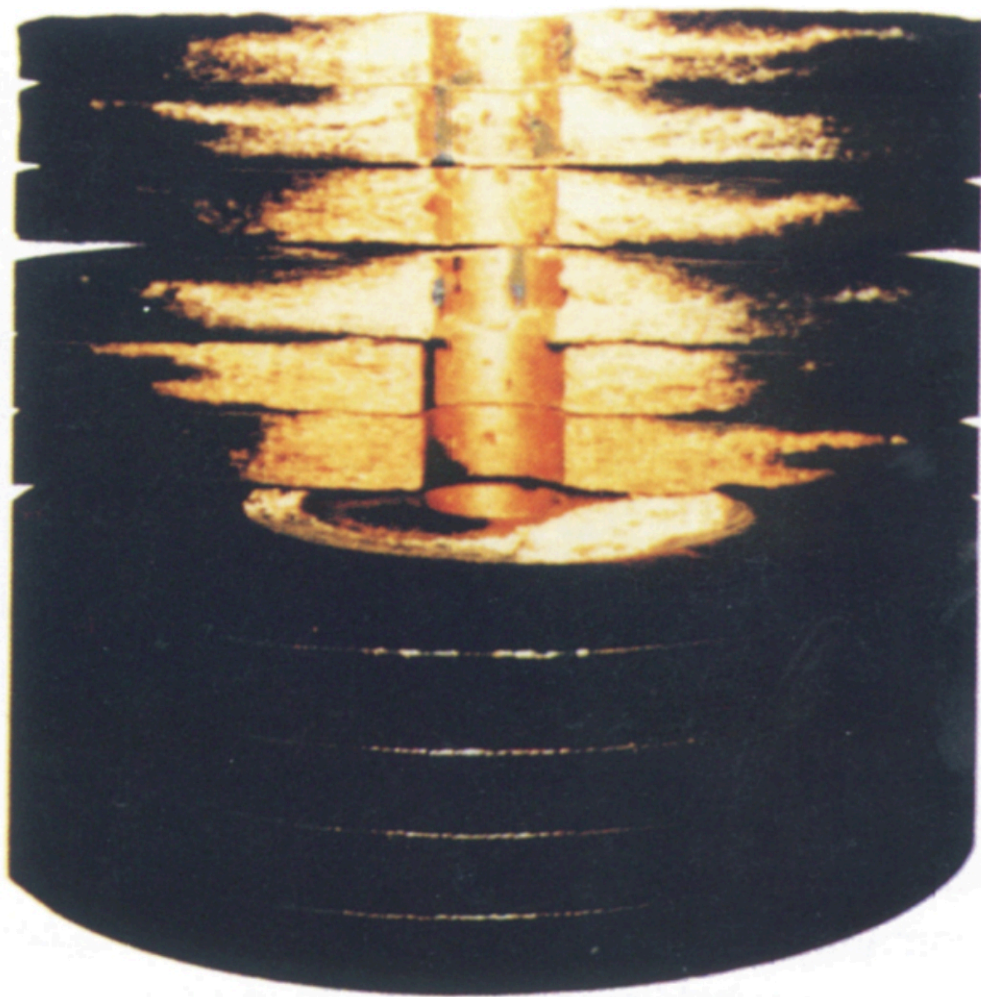
CJC Filter Element

Deep Filtration

Cut-down in used CJC filter insert type
HDU 27/27

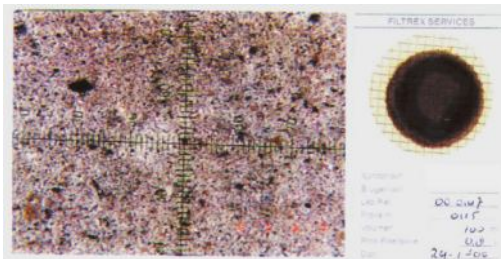
Before Filtration

Wind Turbine Transmission Test

CJC Offline Oil filter

Application Wind Turbine - 600 kW
Oil type Tribol 1710/320
Oil volume 220 liters

| Filtration time: | 0 hours | 48 hours | 1 month |
